**PRELIMINARY GEOLOGIC RECONNAISSANCE
PUMPED STORAGE PROJECTS
KOKO CRATER AND KAAU CRATER SITES
OAHU, HAWAII**

W.O. 3153-00 OCTOBER 22, 1993

OKAHARA & ASSOCIATES

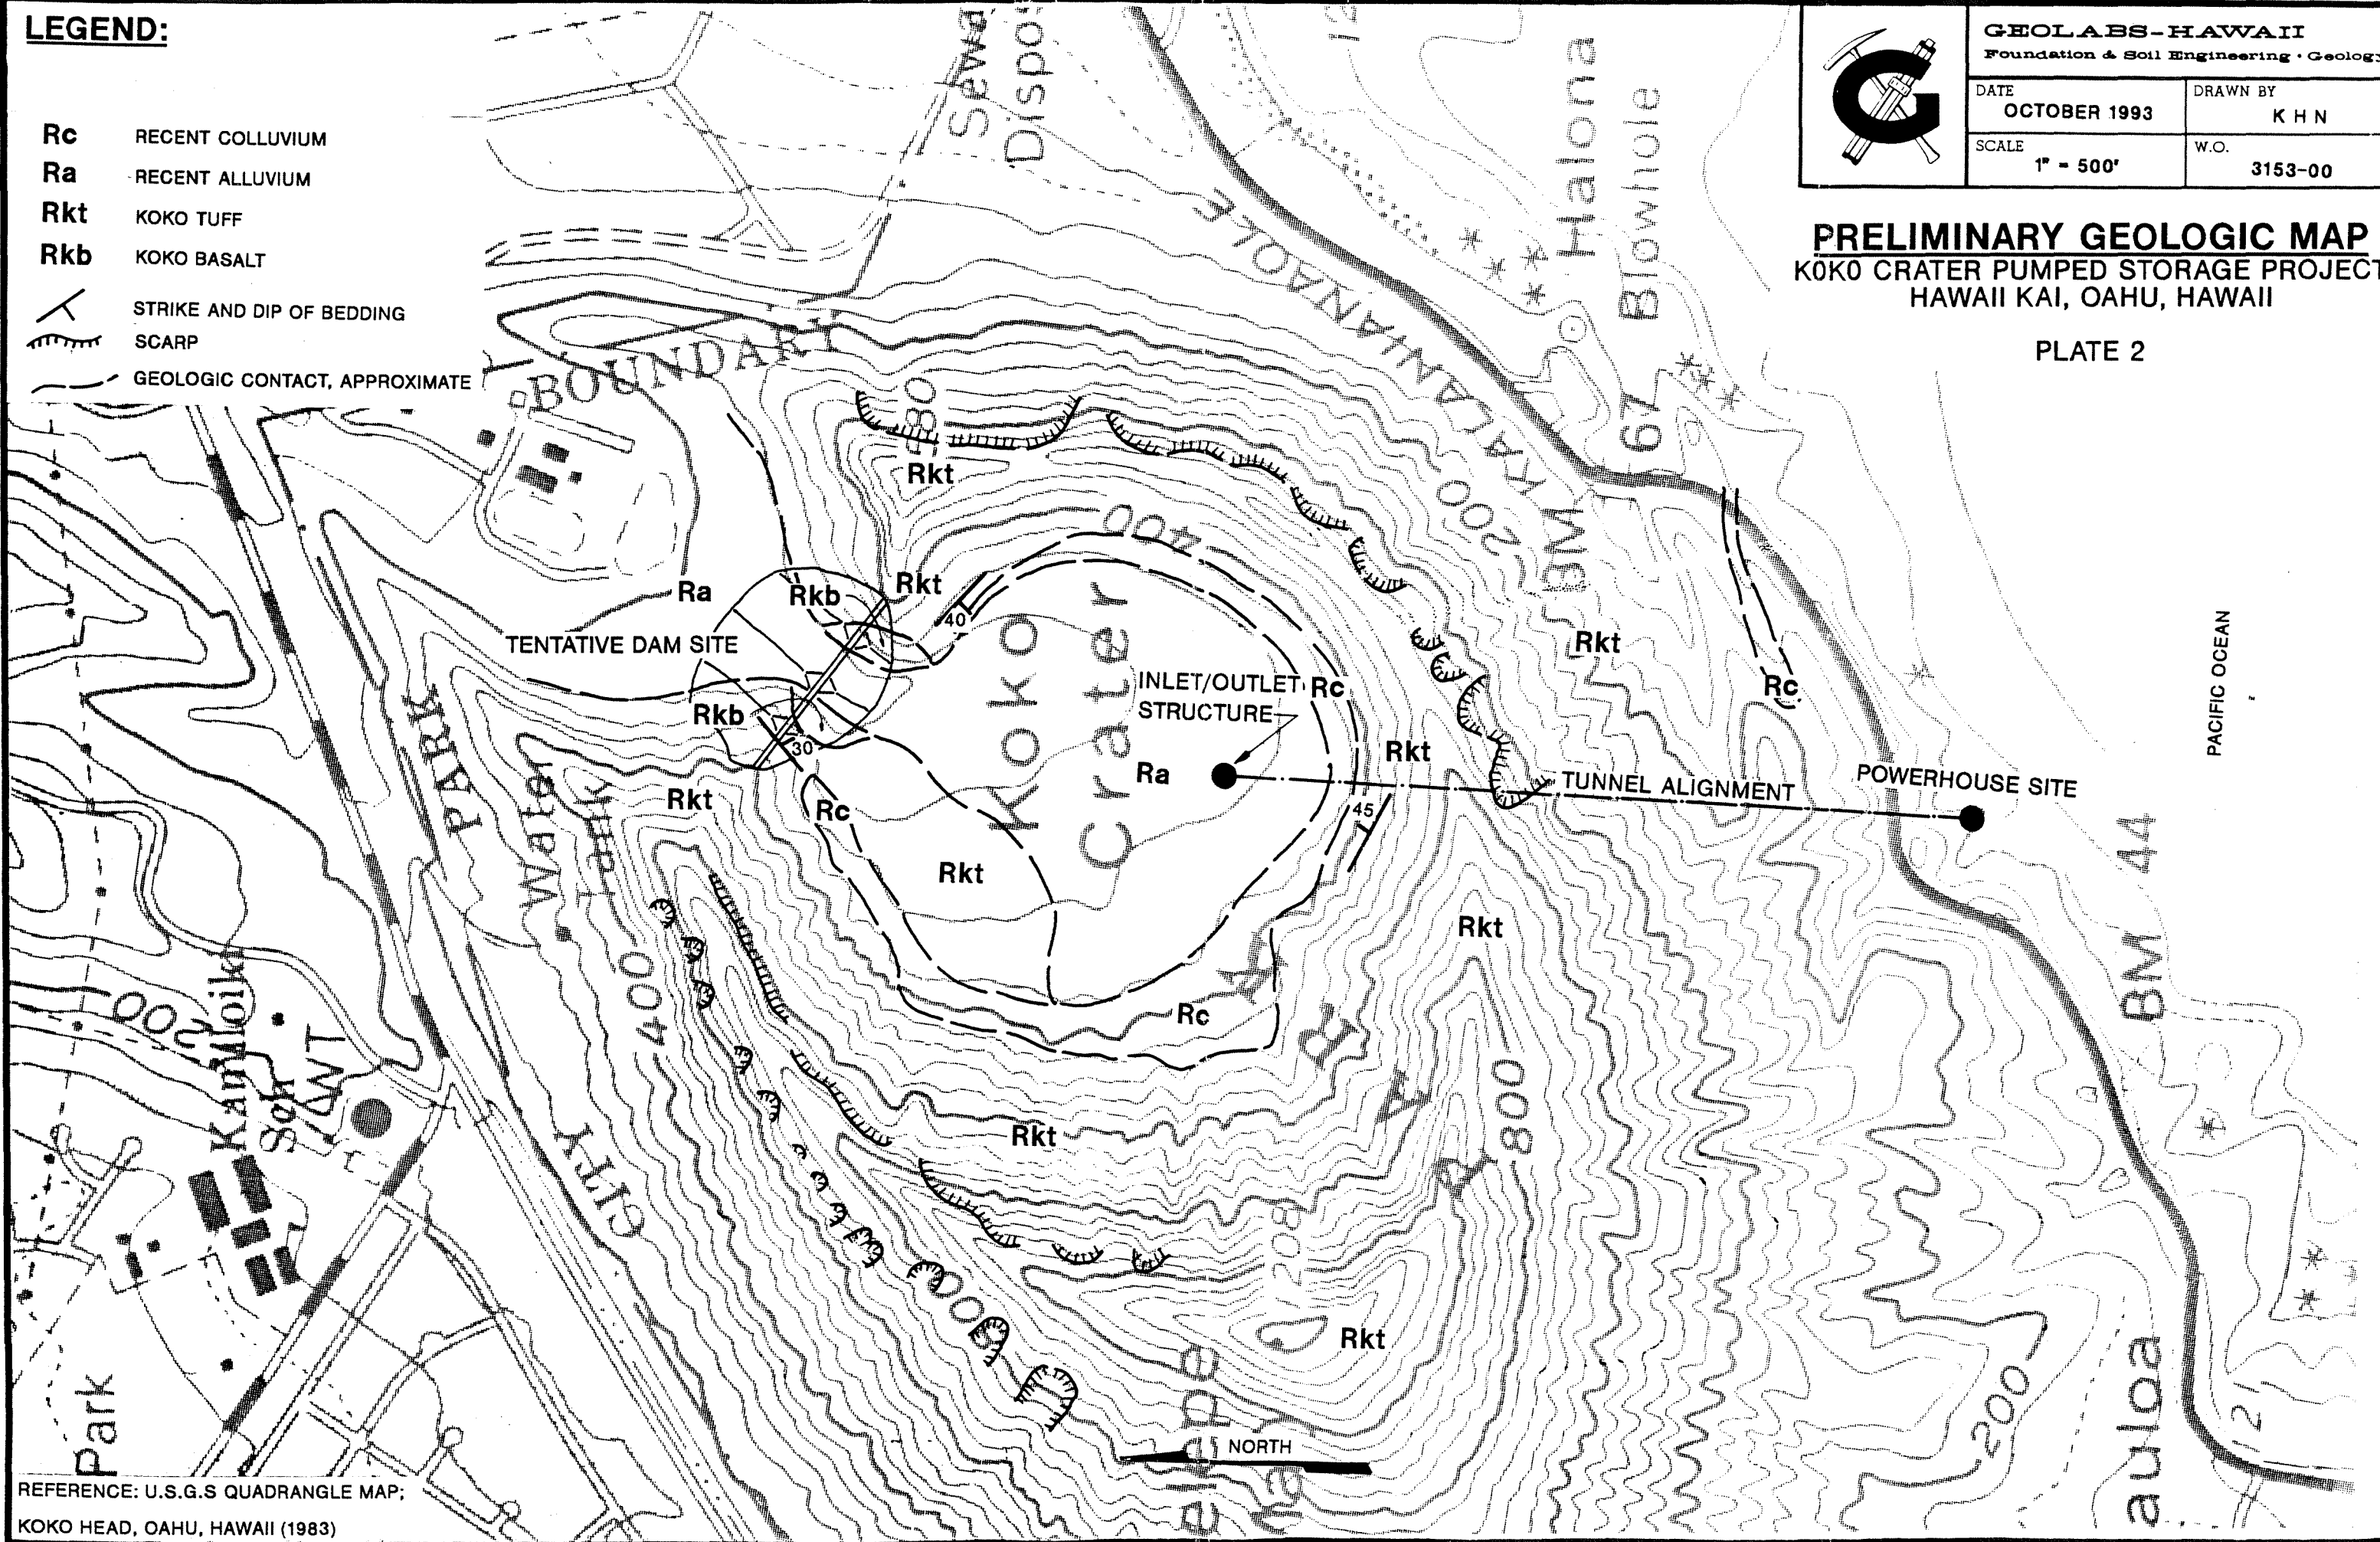
PLATE 2

A preliminary geologic map of the Koko Crater site is presented on the attached Plate 2. Based on our site reconnaissance and examination of aerial photographs, the approximate extent of surficial soil deposits, bedrock structure, and other geologic features have been depicted on the geologic map. Descriptions of the geologic mapping units are presented below:

Koko Tuff - Areas of the site underlain by Koko tuff are shown on the geologic map using the symbol "Rkt." The Koko tuff contains predominantly silt and sand size fragments of ash and volcanic rock. A darker colored cap of opal-cemented tuff is evident around the rim of the crater. Where the cap has been eroded away, the underlying, lighter colored palagonitized tuff is exposed. Following deposition, this tuff has been altered by weathering to palagonite. The palagonite tuff appears to be more easily eroded than the overlying opal-cemented tuff which tends to form the steep cliffs and scarps in the area.

The light brown palagonite tuff exposed in outcrops appears to be weak to moderately strong, highly fractured and varies from thinly to thickly bedded. The dark brown opal-cemented tuff also appears to be weak to moderately strong but appears to be moderately to occasionally fractured.

Structurally, the Koko Tuff is complex. The dominant structural feature is an antiform with an axis that corresponds roughly with the rim of the crater. In general, beds on the exterior of the crater dip away from the center of the crater whereas beds on the interior of the crater dip toward the center of the crater. A notable exception to this configuration is evident along the interior, northwest slope of the crater where the inward dipping beds appear to have been eroded away to expose outward dipping beds. Horizontally stratified tuff was observed in gullies in the northwest portion of the crater

Koko Basalt - Basaltic "aa" volcanic rock was exposed on both the northwest and southeast sides of the crater gap. These areas are shown on the geologic map using the symbol "Rkb." This volcanic rock appears to have chaotic structure with no evident bedding. The "aa" appears to consist of a dense mass of vesicular basaltic rock fragments.

Alluvium - Alluvium is soil material that has been deposited by flowing water. Portions of the study area that appear to be underlain by alluvium are indicated on the geologic map using the symbol "Ra." Alluvium was exposed in gullies eroded in the crater floor. At the crater gap, an exposure of alluvium over 20 feet thick was observed in the stream course consisting of sandy silt with gravel and cobbles. Elsewhere in the crater, gullies exposed alluvium consisting predominantly of sandy silt with cobbles and boulders. The alluvium generally appeared to be medium dense to dense although some porous gravel beds were observed.

Colluvium - Colluvium is material that is deposited by processes such as slope wash, sheet erosion, rock fall, etc. The transition slope on the interior of the crater between the relatively flat crater floor and the steep side slopes appears to be underlain by colluvium which is designated by the symbol "Rc" on the geologic map. The colluvium appears to contain predominantly of cobbles and boulders with some sandy silt matrix. Abundant boulders up to 10 feet in diameter were observed along the west side of the crater floor.

Landsliding - Evidence of rockfall and rock slides is visible on both the interior and exterior slopes of the crater. The dip slope conditions combined with undermining of the more easily eroded palagonite tuff appears to have resulted in rockfall and rock slides. Scarps resulting from these slope movements are shown on the geologic map using a hatched line.

Photolineaments - Two linear valleys cross the proposed tunnel alignment near Kalanianaʻole Highway. Both valleys trend roughly perpendicular to the tunnel alignment. The trend of these valleys is somewhat anomalous when compared to the general drainage pattern in the area. As noted in the discussion regarding alluvial deposits, tuff was observed in the stream bottom of the northern valley. No signs of shearing and no significant difference in the makeup or structural orientation of the tuff were noted on either side valley. Macdonald (1970) interprets these landforms as remnants of the rim of an older tuff cone that has been almost completely eroded away by wave action. Additional investigation of linear valleys would be needed to these understand the origin of these landforms and the possible impact to the project.

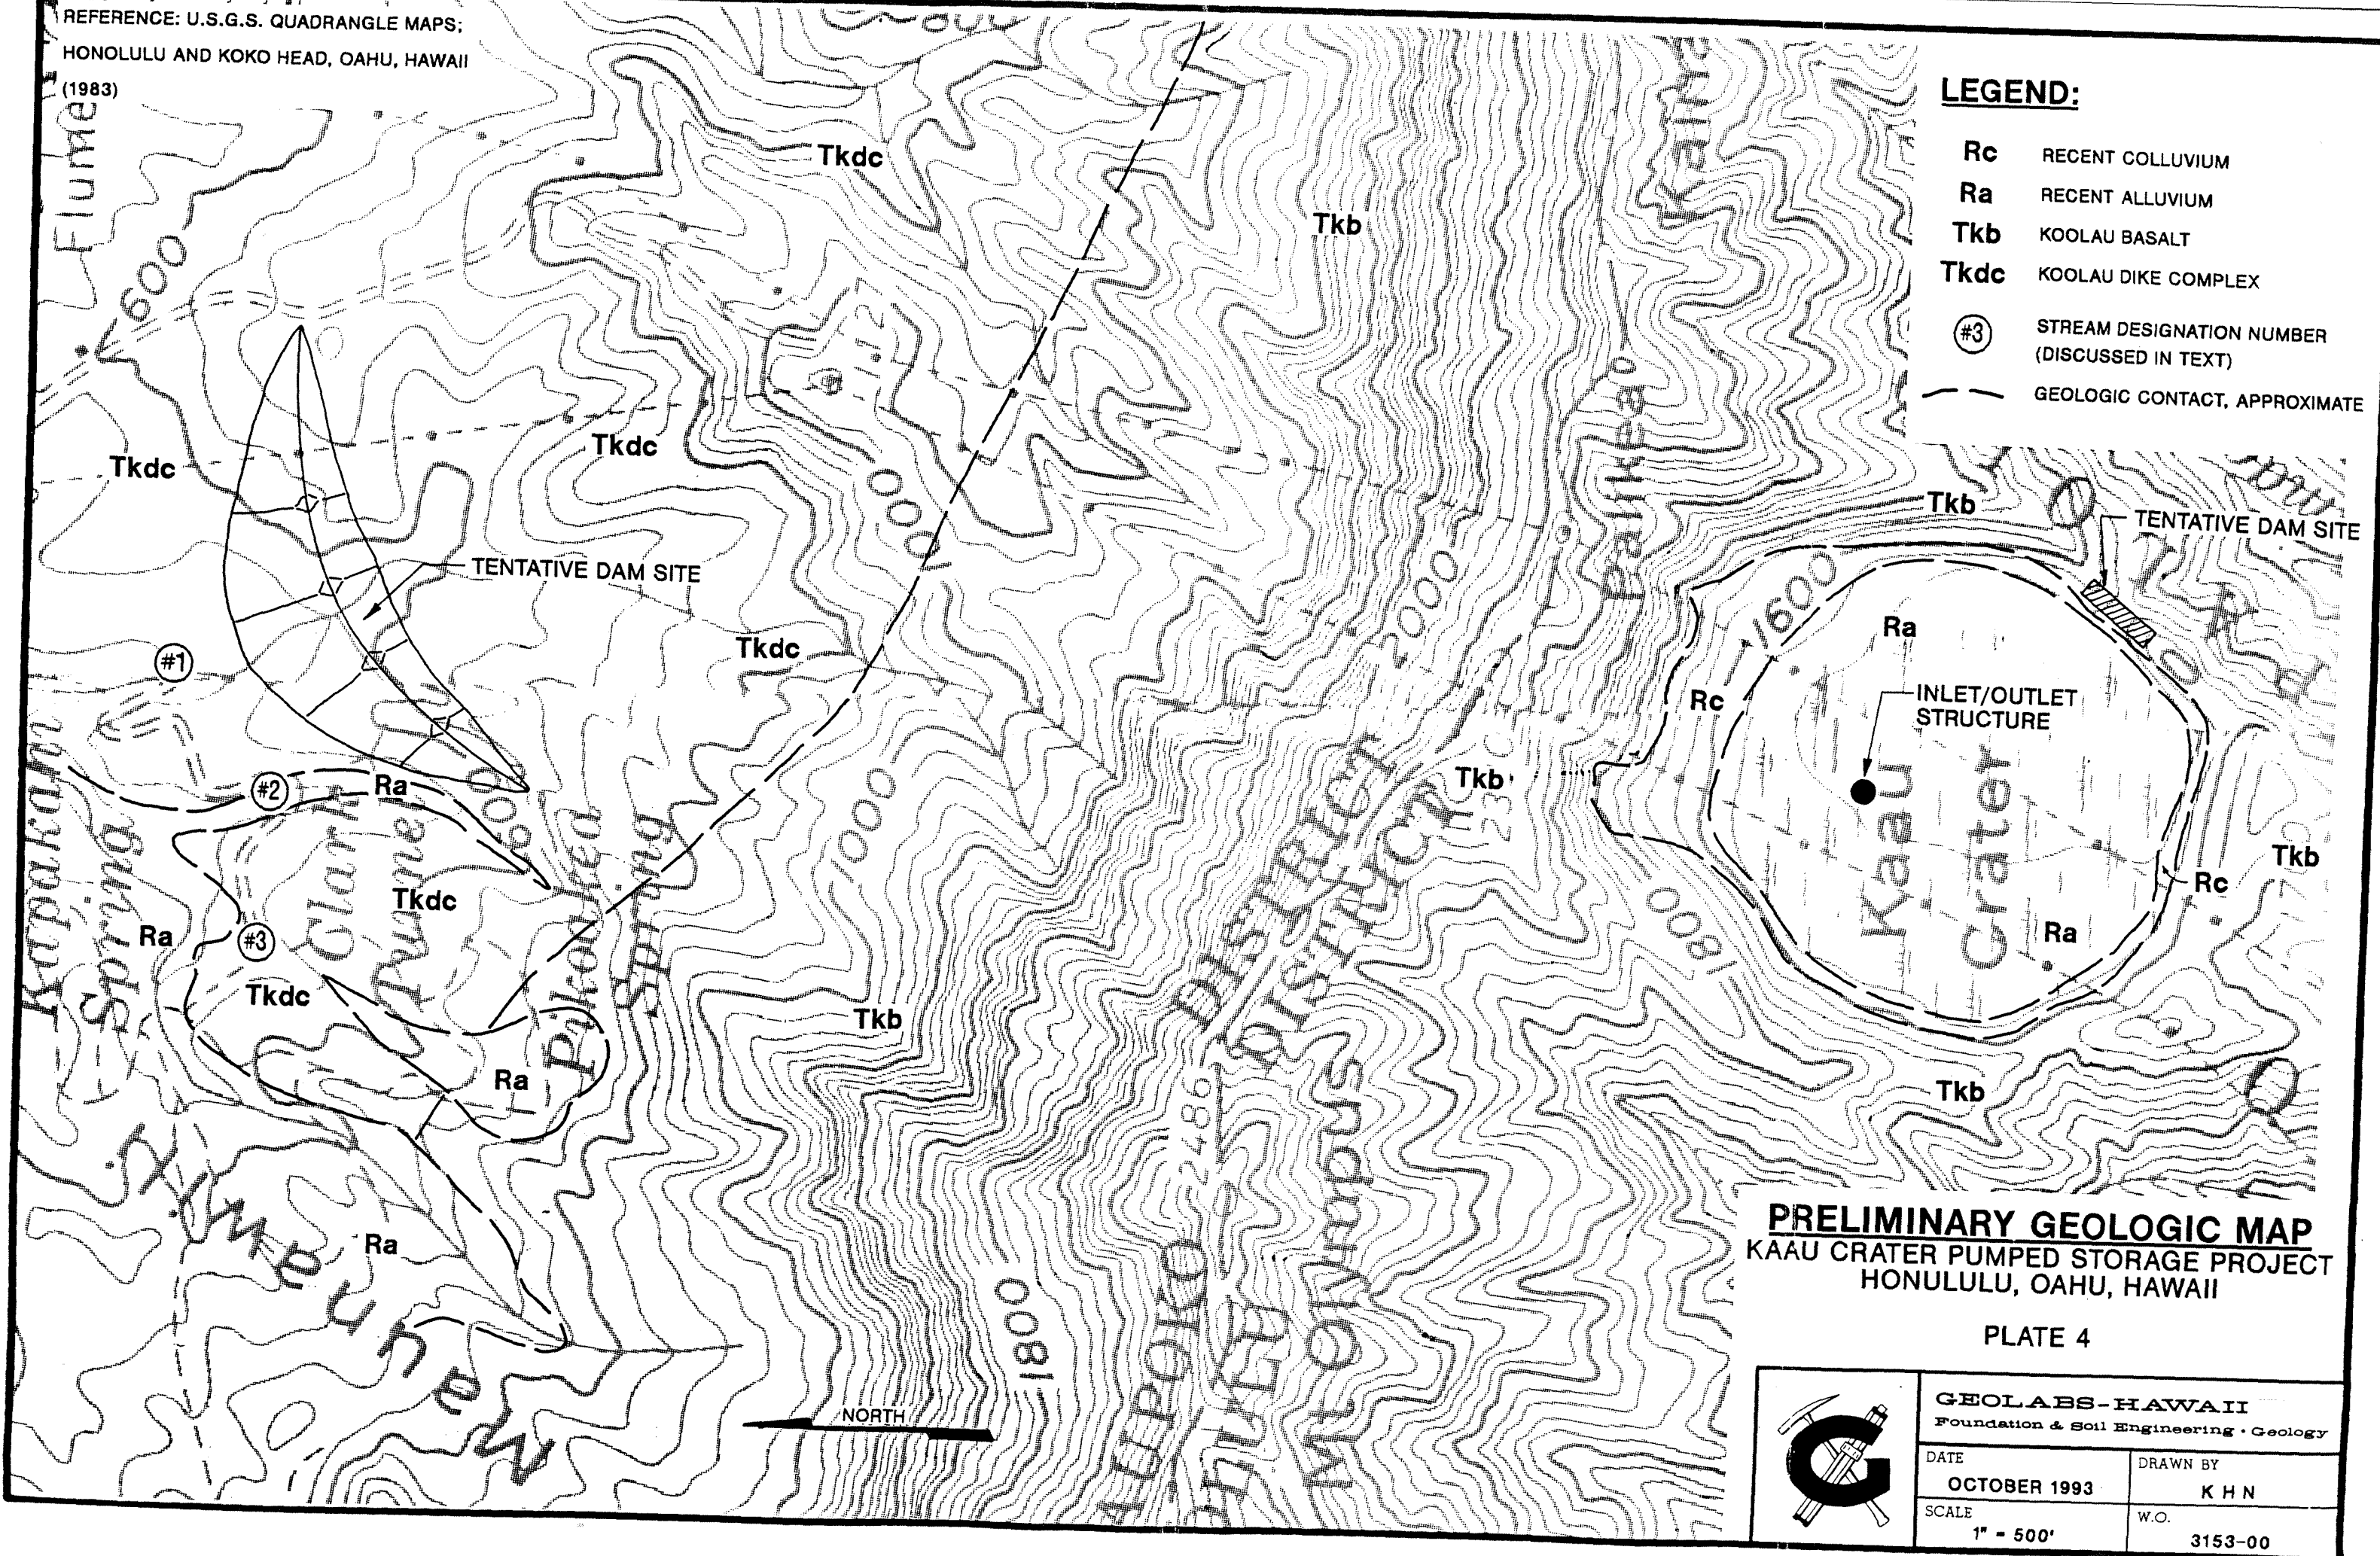
PLATE 4

A preliminary geologic map of the Kaau Crater and Maunawili sites is presented on the attached Plate 4. Based on our site reconnaissance and examination of aerial photographs, the approximate extent of surficial soil deposits, bedrock structure, and other geologic features have been depicted on the geologic map. Descriptions of the geologic mapping units are presented below.

Koolau Dike Complex - Portions of the study area underlain by the Koolau dike complex are shown on the geologic map using the symbol "Tkdc." Rock of the Koolau dike complex generally consists of gray to black near vertical basalt dikes ranging from several inches to several feet thick. Only limited exposures of rock were visible at the Maunawili site. In stream bottoms and at Pikoakea Spring, the basalt exposed appeared to be strong to very strong, with few vesicals, and range from highly to occasionally fractured.

Koolau Basalt - The crest of the Koolau range and the area around Kaau Crater are underlain by Koolau basalt as indicated on the geologic map using the symbol "Tkb." Koolau basalt varies from dense to very vesicular and typically has nearly horizontal structure. Basalt exposures at the gap in Kaau Crater were moderately weathered, highly fractured with massive structure. "Stair stepping" patterns on the cliff faces of the Koolau range suggest alternating layers of dense, massive basalt and layers of less dense, highly fractured or more erodible basalt.

Alluvium - Alluvium is soil material that has been deposited by flowing water. Portions of the study area that appear to be underlain by alluvium are indicated on the geologic map using the symbol "Ra." Alluvium was exposed in gullies eroded in the crater floor and in stream courses in the Maunawili valley.

Alluvium within Kaau Crater probably consists of silt and clay with some interlayered organic material or peat. The alluvium in the crater was observed to be saturated and soft. Men walking across the crater floor sink into the soft silt and clay 3 to 6 inches. Beneath the soft silts and clays, coarser grained alluvium may exist in the crater.

Stream courses in the Maunawili reservoir area have been numbered Nos. 1 through 3 on the geologic map for discussion purposes. Where the access road crosses Stream No. 1, in-situ basalt appears to be exposed in the stream bottom. Small pockets of alluvium may be present upstream of the access road; however, the stream generally appears to be in an erosive mode. Where the access road crosses Stream No. 2, alluvial in-filling of the valley was approximately 150 feet wide and could be on the order of 30 feet or more in thickness. The alluvium exposed in the stream bank consisted of dense clayey sand and gravel. Several hundred feet upstream of the access road, near Pikoakea Spring, the alluvial deposit narrowed to only about 20 feet wide with an estimated thickness of about 10 feet. In-situ basalt was exposed in Stream No. 3 where the access road crosses the stream.
